Service Bulletin

Bulletin No.: 17-NA-384

Subject: Squeak, Rattle or Creak Coming from Second Row/Rear Seat Area

Brand:	Model:	Model Year:		VIN:		Engine:	Transmission:
		from	to	from	to		
Cadillac	XT5	2017	2019			All	All
GMC	Acadia (VIN N)

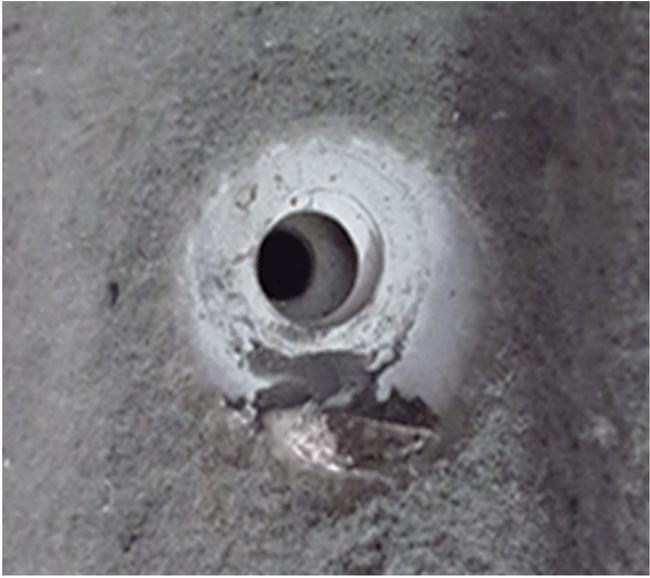
<p style="text-align: right;">4911773</p> <p>Note: The "winking" is caused by excessive overlap of body panels and, as shown in the graphic above, the sheet metal holes are offset. This is most commonly found at the right rear fastener location of the right rear seat, or the left rear fastener of the left rear seat.</p> <ul style="list-style-type: none"> • Possible "winking" condition of right rear 40% seat floor pan outboard track rear bolt hole, or the left rear 60% seat floor pan outboard track rear bolt hole. • A seat track synchronization/torque condition may require a torque sequencing of the seat attachment bolts, on either seat.

Correction	<p>Note: Perform the "winking" inspection, and repair procedure as necessary first, prior to performing the torque procedure.</p> <p>For vehicles exhibiting the condition, follow the Service Procedure below to inspect for and correct the winking condition, and also complete the torque sequencing procedure.</p>

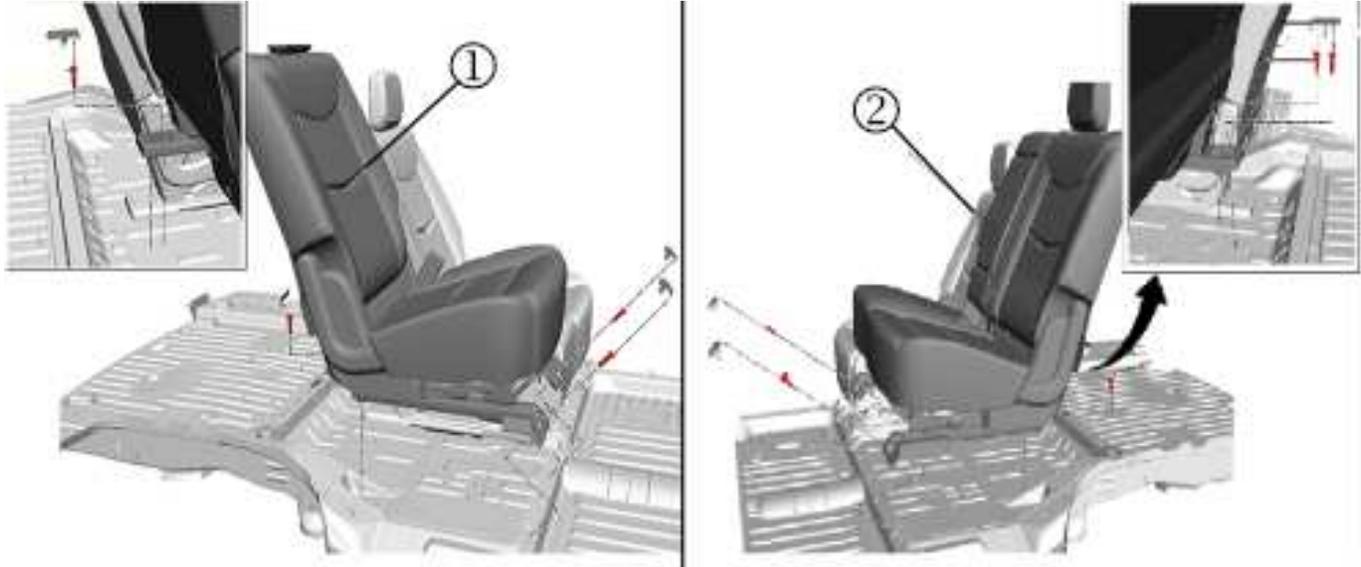
5403437

1. Verify which rear seat exhibits the condition: the right rear 40% seat, (1) and/or the left rear 60% seat. (2)

2. Remove the affected right (1) and/or left (2) rear seat. Refer to *Rear Seat Removal and Installation (40%)* and/or *Rear Seat Removal and Installation (60%)* in SI,
 - 2.1. Adjust the seat to full rearward position.
 - 2.2. Loosen the outboard front attachment bolt, then the inboard bolt.
 - 2.3. Adjust the seat to full forward position.

Note: It is important that the tracks remain locked until both rear bolts are re-torqued.

- 2.4. Ensure that both seat tracks are locked.
- 2.5. Loosen the outboard rear attachment bolt, then the inboard bolt.

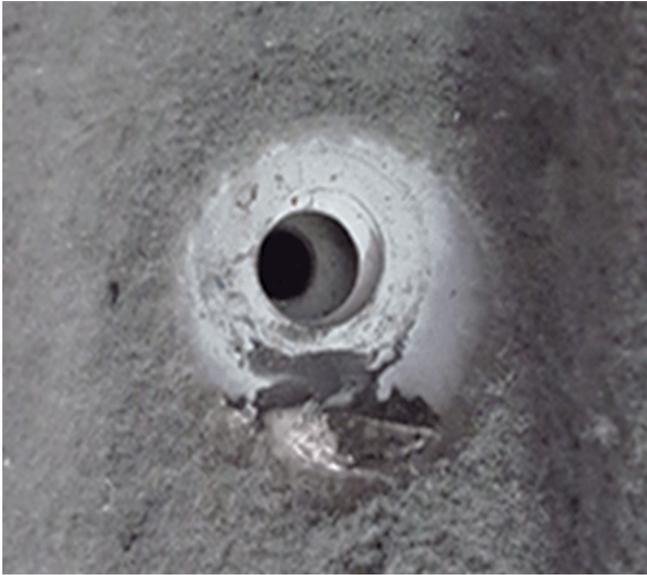
4911773

3. inspect the right outboard rear seat fastener location of the right rear seat and/or the left outboard rear seat fastener location of the left rear seat for possible “winking” condition:

4. Using a dremel, or suitable tool, grind a small amount of material from the floor sheet metal opening. Grind only enough of the overlapping metal to allow clearance for the seat bolt.
5. Use an air gun to blow out any metal debris in the nut and hole area.

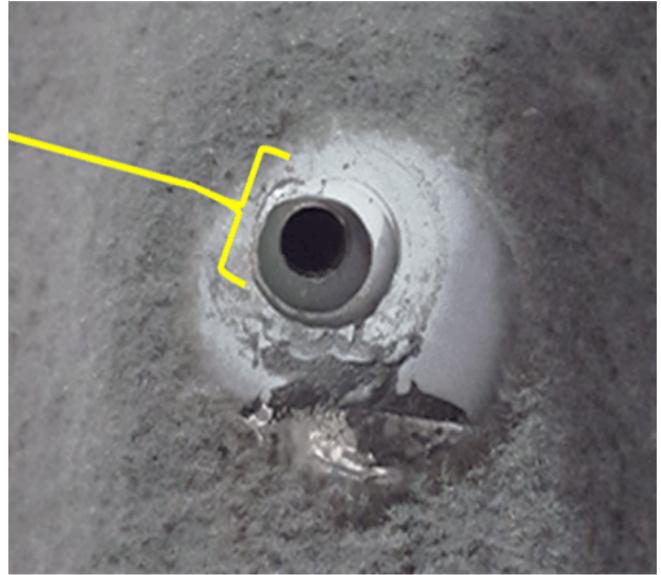
4911785

- If “winking” condition DOES exist, continue ahead to step #4 and remove sheet metal material.

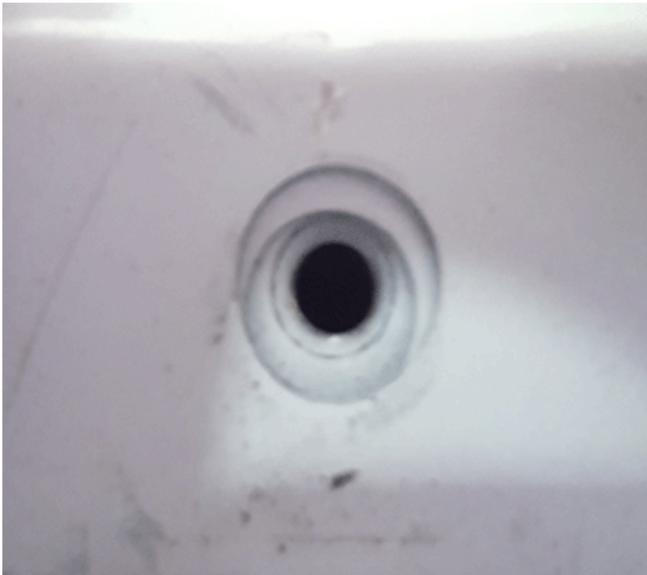
4911781

Note: In the graphic example above, the sheet metal is still offset, but the nut is centered enough to avoid contact of the seat bolt to the sheet metal.

- If “winking” condition DOES NOT exist, jump ahead to step #6 and follow the torque sequence procedure.
